Yacht Salvage Stability M/Y Baden Stability Evaluation

PREPARED FOR: Global Diving & Salvage, Inc. Seattle, WA		BY: Kyle C. Beattie, PE PROJECT NAVAL ARCHITECT

THE GLOSTEN ASSOCIATES 1201 Western Avenue, Suite 200, Seattle, WA 98101-2921 www.glosten.com		CHECKED: Matthew S. Miller, PE PRINCIPAL	
		APPROVED: John A. Springer, III, PE PRINCIPAL-IN-CHARGE	
DOC:	REV: -	FILE: 14066.01	DATE: 22 May 2014

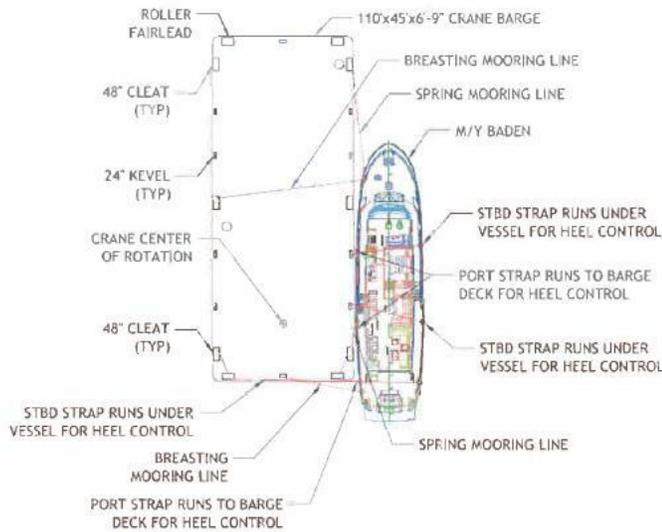
Figure 1: Transport Mooring Configuration

There shall be three sets of heel control lines, though the design load is based on one set. Breasting and spring lines shall be located forward and aft. See the figure below.

The proposed, and current, configuration of a crane barge hooked to a port and starboard sling and secondary lines on both the port and starboard side of the yacht attached to the barge deck fittings provides necessary stability. The secondary lines control the heel of the vessel with a port line connected down to the crane barge deck (preventing a roll to starboard) and a starboard line fed under the hull and up to the main deck (preventing a roll to port).

During transport, the crane will be unloaded but maintain the connections to the aft slings in case extra support is required. The forward slings (secondary lines) are intended to control the heel of the vessel.

It is recommended that the tow be as short as possible and occur at a slow speed, in calm conditions, with minimal wind.
