## Marine Safety Inspection

**Contract Number :** 2014PC/4038

**Date of Inspection :** July 23, 2014

To inspect the auxiliary sailing vessel [redacted] license number [redacted] to determine its suitability for in water moorage with regards to the safety of its structure and systems.

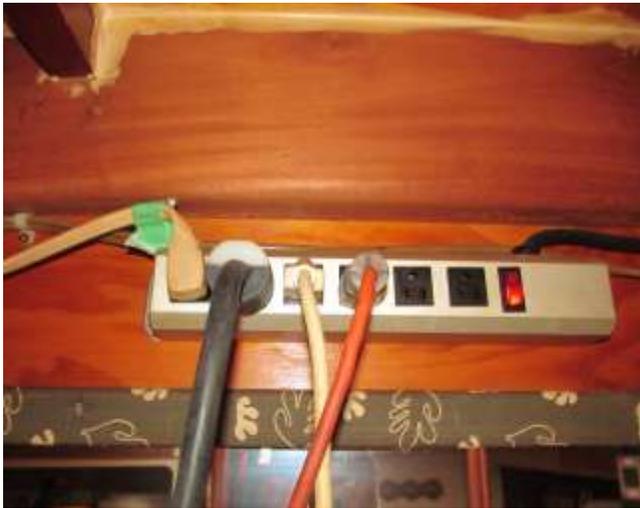
*Outlet multiplier #1*

AC system - Although eleven outlet multipliers were sighted, there may be more. Twenty one extension cords (some homemade with reversed polarity), outlet multipliers and lack of any circuit protection or AC/DC ground bonding whatsoever pose a significant ESD, electrocution and fire hazard. DC system – Wiring was incomprehensible and much appeared without any circuit protection and many connections are made with twisted wire covered with various types of adhesive tape.

The AC and DC power systems must be disconnected, all outlet multipliers and extension cords to be removed from the vessel pending a complete electrical inspection. All hatches, lockers, bilge or any other compartment containing electrical systems or parts thereof be made readily accessible for such inspection.

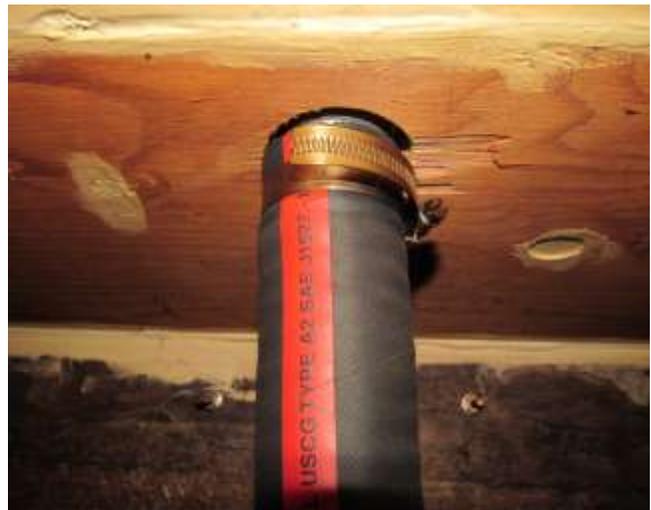
The Volvo diesel engine and drive system are securely installed and appear little used. The fuel system is neither grounded nor secured in accordance with required standards.

*One of three ungrounded fuel fill connections*

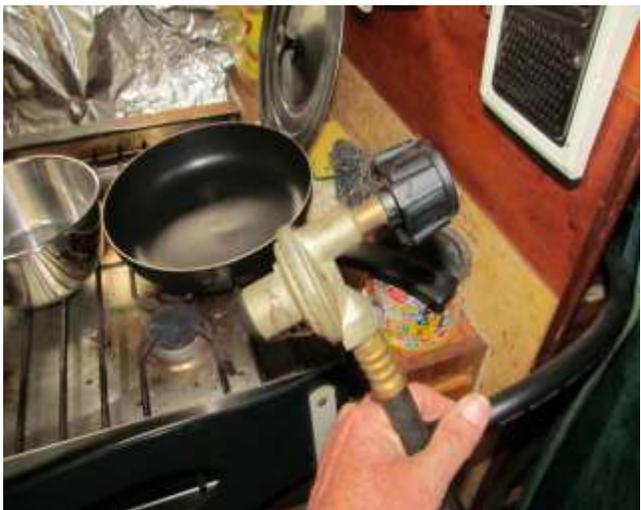
A propane stove/oven is fitted and the fuel line terminates at a pressure regulator in the aft companionway. This fuel line is not fitted with a pressure regulator and is not long enough to reach outside the hull and no approved type propane storage locker is fitted. The fuel line will reach a 20lb. propane tank stored in the non-ignition protected environment of the bilge forward of the engine compartment.

*Propane line and regulator near galley*

The propane tank must be immediately removed from the vessel and no propane system onboard to be used until proper fuel supply and storage systems are fitted.

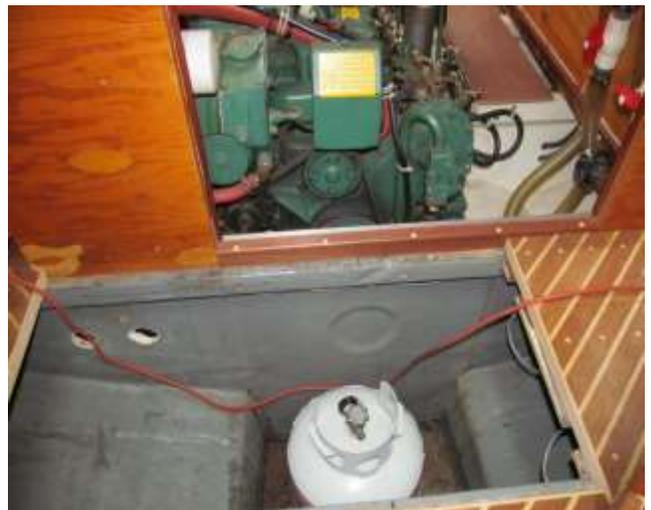
*20lb. propane tank in bilge*

Storing propane inside the vessel in this manner is an immediate threat to the vessel, crew and any nearby boats and harbour personnel. At time of inspection there were no provisions onboard for safe installation of a propane storage or fuel supply system to the galley stove.

Upon discovering the propane tank in the bilge exposed to non-ignition protected equipment, I immediately disembarked due to safety concerns therefore this inspection must be considered incomplete.
