Marine Safety Inspection

Contract Number : 2014PC/3038

Date of Inspection : July 23, 2014

To inspect the auxiliary sailing vessel [redacted] to determine its suitability for in water moorage with regards to the safety of its structure and systems.

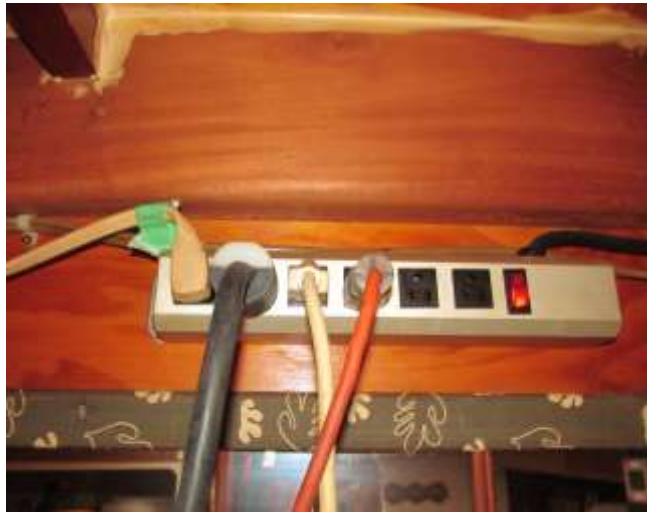
Outlet multiplier #1

A complete and accurate assessment of the electrical system is unlikely due to the number and general disarray of various extension cords and outlet multipliers. Inspection is also limited because of limited access due to the large volume of loose gear onboard.

Although eleven outlet multipliers were sighted, there may be more. This number of extension cords and outlet multipliers in themselves pose a fire hazard.

All outlet multipliers and extension cords to be removed from the vessel pending a complete electrical inspection. All hatches, lockers, bilge or any other compartment containing electrical systems or parts thereof be made readily accessible for inspection.

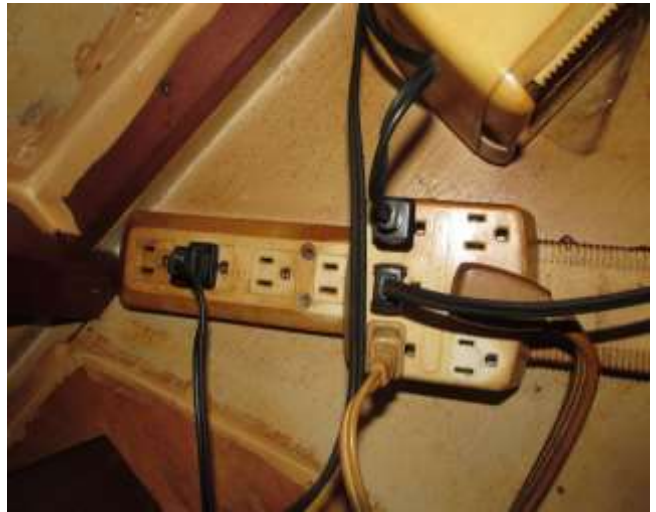
Outlet multiplier #2 & #3

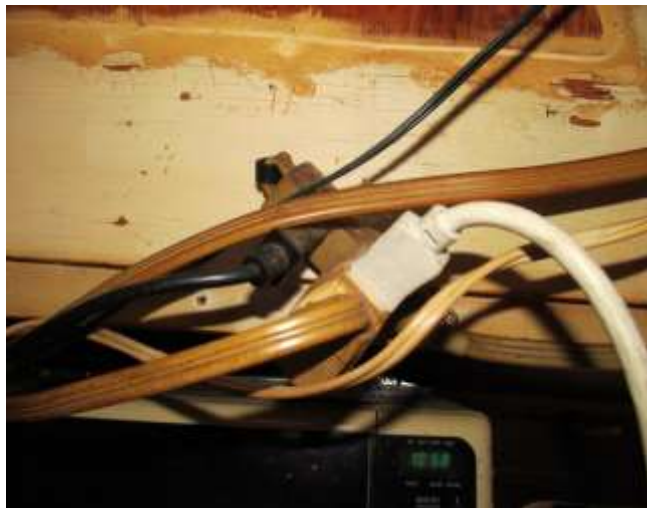
Outlet multiplier #4 & #5

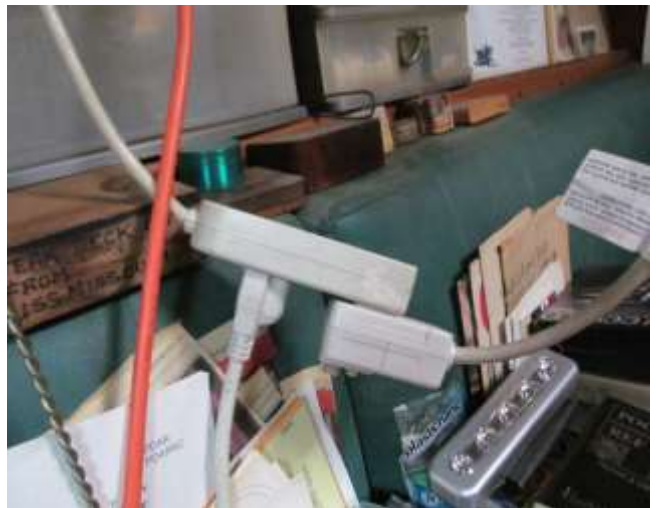
Outlet multiplier #6

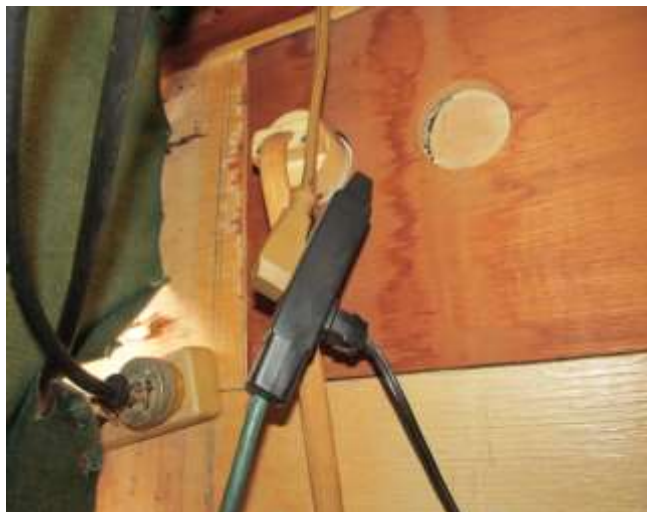
Outlet multiplier #7

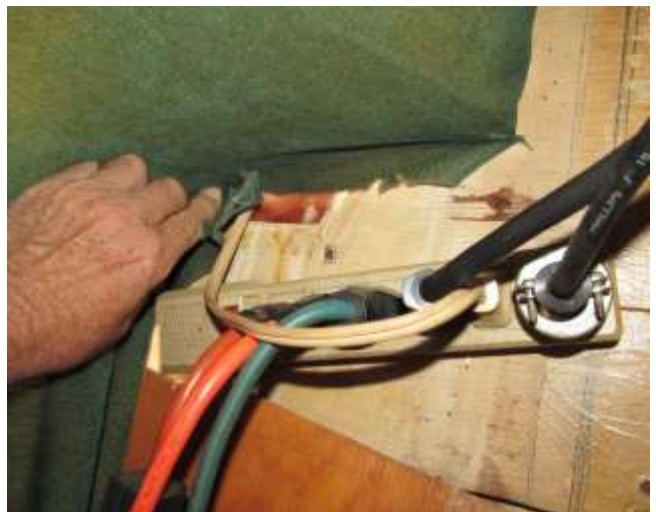
Outlet multiplier #8

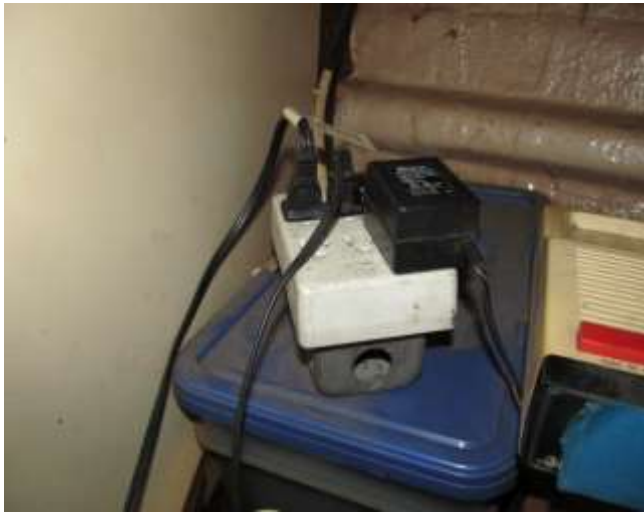
Outlet multiplier #9

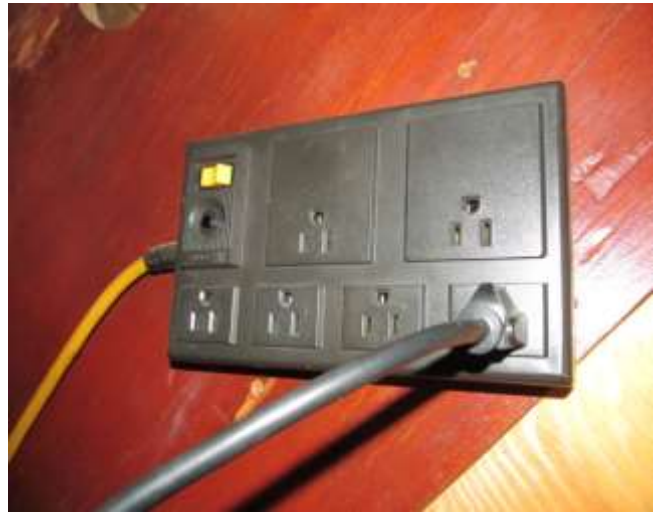
Outlet multiplier #10

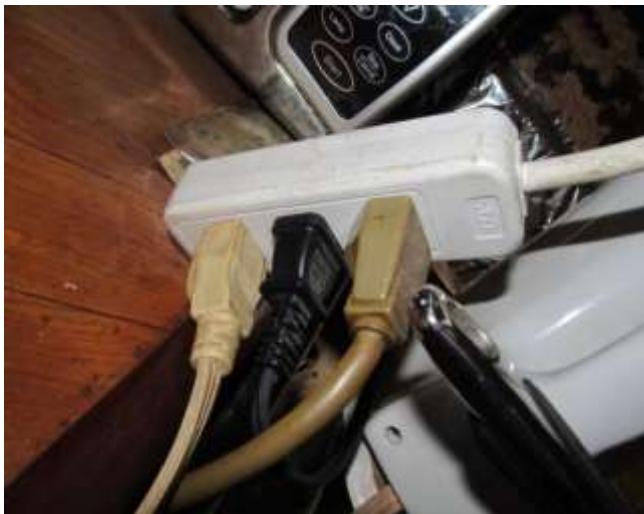
Outlet multiplier #11

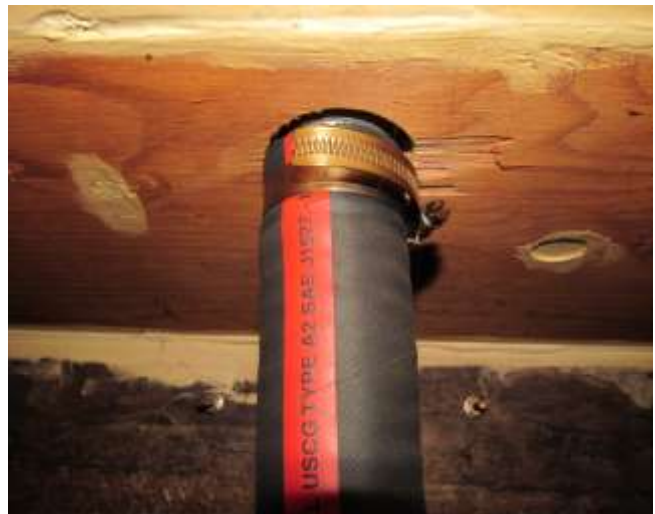
The Volvo diesel engine and drive system are securely installed and appear little used. The fuel system is neither grounded nor secured in accordance with required standards.

One of three ungrounded fuel fill connections

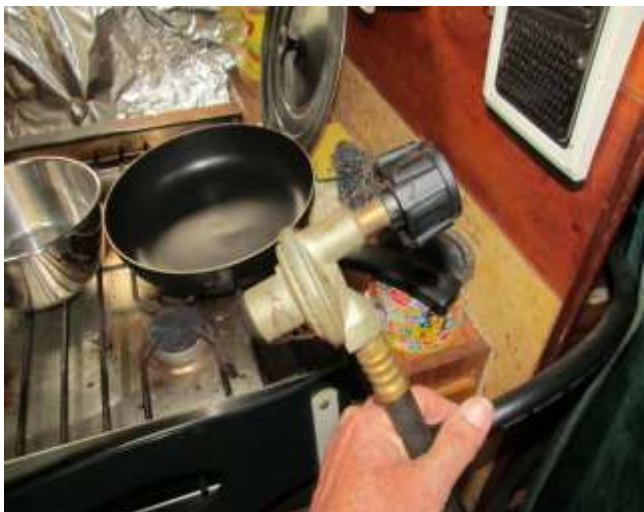
A propane stove/oven is fitted and the fuel line terminates at a pressure regulator in the aft companionway. This fuel line is not fitted with a pressure regulator and is not long enough to reach outside the hull and no approved type propane storage locker is fitted. The fuel line will reach a 20lb. propane tank stored in the non-ignition protected environment of the bilge forward of the engine compartment.

Propane line and regulator near galley

The propane tank must be immediately removed from the vessel and no propane system onboard to be used until proper fuel supply and storage systems are fitted.

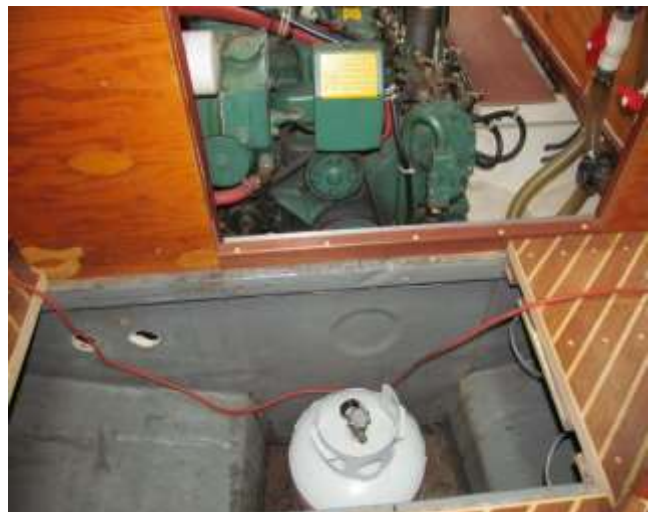
20lb. propane tank in bilge

Storing propane inside the vessel in this manner is an immediate threat to the vessel, crew and any nearby boats or personnel. At time of inspection there were no provisions onboard for safe installation of a propane storage or fuel supply system to the galley stove.
