Marine Survey Report

Report Number : 2013P/2850

Date of Inspection : May 20 and 21, 2013. Title page photo May 17, 2013

Make of Vessel : The MIC is registered to Cherry Yachts, 454 S Queen St. HAMPTON, VA as the importer from Kha Shing Ent., Co., Ltd., 10 Kang Yang St., Hsial Kang, Taiwan R.O.C Marketed as a "Sundowner 30" and a "Regency 30".

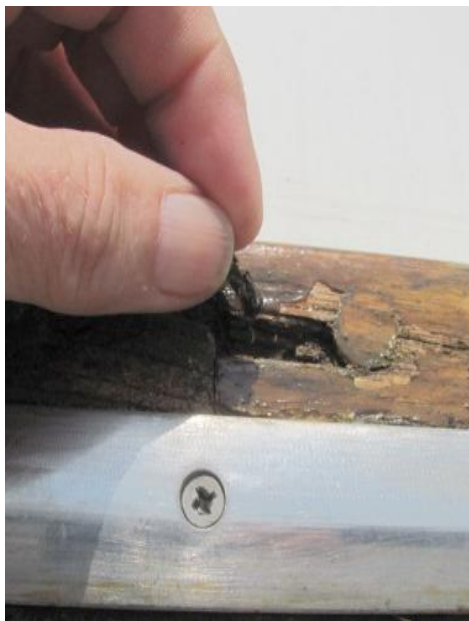
Check sound and appear fair and with no more than some minor scuffs and abrasions. Wooden rub rails are secure and generally sound with a few small soft areas. **See comment (1).**

Soft spot on rub rail

1. Repair and re-finish wooden rub rail as required.
2. The hairline fractures in the gelcoat on keel and bottom are cosmetic issues and may be addressed if desired. The high moisture levels measured on the bottom exterior are likely due to a high capacitance paint under the VC17 anti-fouling paint as interior measurements showed low moisture levels.

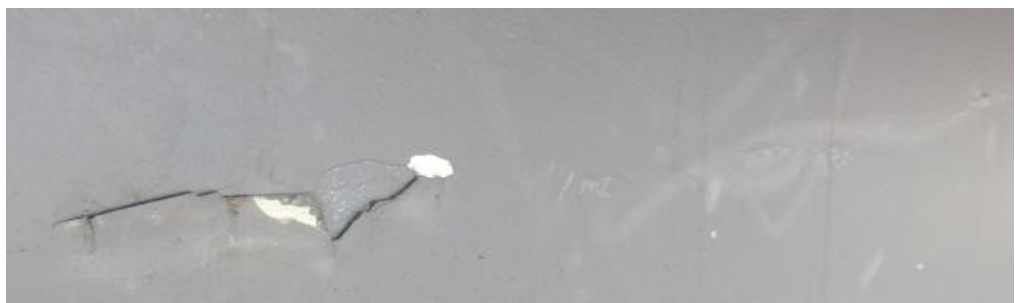
The keel checks sound and shows variable moisture levels on exterior surfaces from low to high. The starboard side of the keel shows some flaking gelcoat which reveals more gelcoat underneath and hairline fractures. **See comment (2).**

Flaking gelcoat on keel to starboard

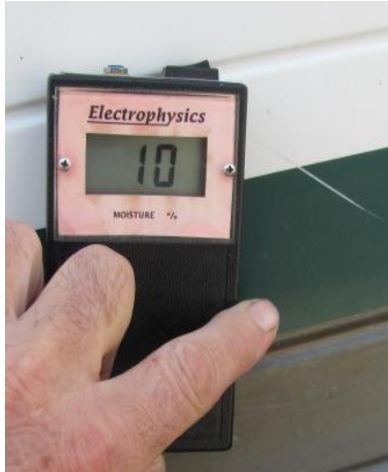
Low moisture above waterline

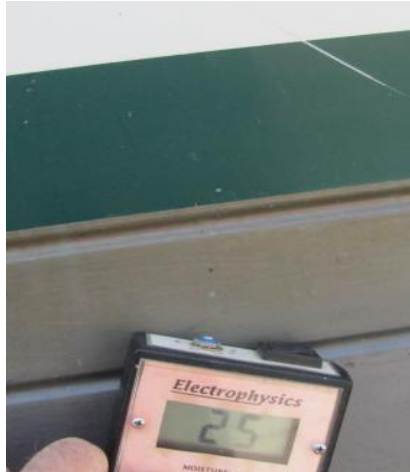
The bottom is fair and checks sound with moisture levels in the high range. On interior surfaces where accessible, moisture levels were in the low range. Multiple layers of antifouling paint are in satisfactory condition. Hairline fractures are noted near the starboard bow. **See comment (2).**

High moisture below waterline

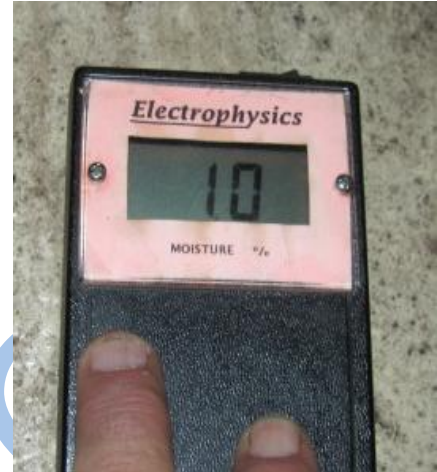
Low moisture interior surface

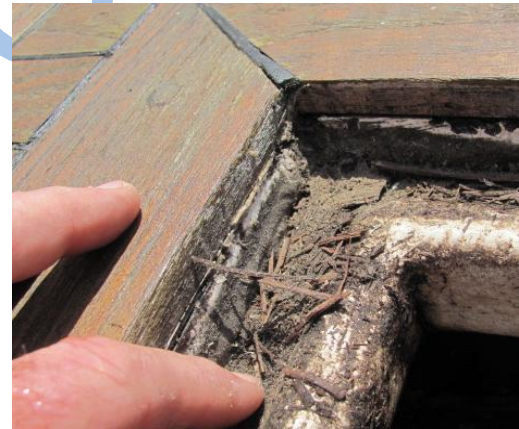
The main exterior decks are covered with teak planking in sound condition. Where accessible from the underside, moisture levels are high and soundings produce a dull report. The gutters around the lazarette hatch have no means of drainage and the deck core in this area is very soft with high moisture as is the hatch itself. **See comment (3).**

Deck hatch gutter without drains

3. The high moisture and dull checking on the underside of the decks and lazarette hatch pose no threat to the vessel or crew but do have a negative effect on value due to the high cost of repair.

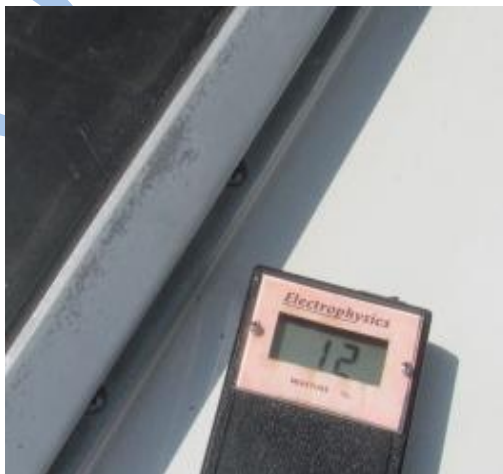
Fore trunk low moisture

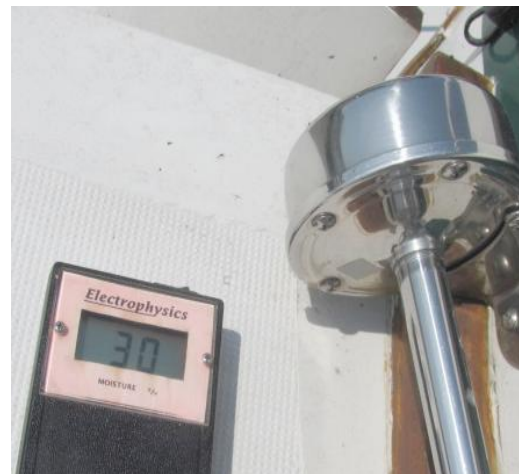
The deck house and pilot house show variable moisture from low to high but all surfaces are serviceably sound. The fore trunk shows low moisture levels. **See comment (4).**

Pilot house deckhead -high moisture

4. The areas of high moisture on the deck house and pilot house pose no threat to vessel or crew as they are serviceably sound. . Re-bedding all fasteners and fittings may help extend the life of the core.

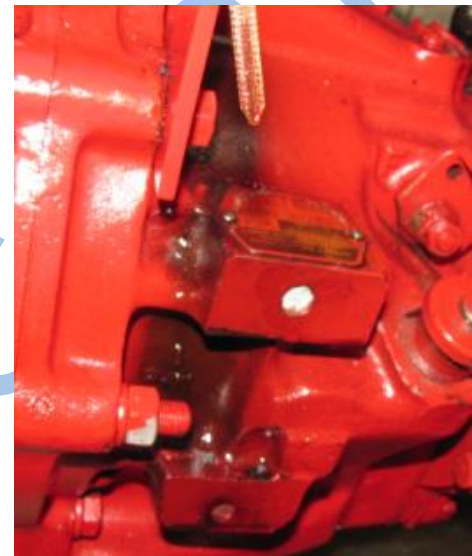
Oil on port side of gear reduction

- 5a. Oil on the gear reduction unit appears to be coming from the bottom of the oil filter or filter housing. Additional oil was visibly leaking during the sea trial. This may be simply a poor gasket seal or oil hose union. It should be repaired prior to any voyage.

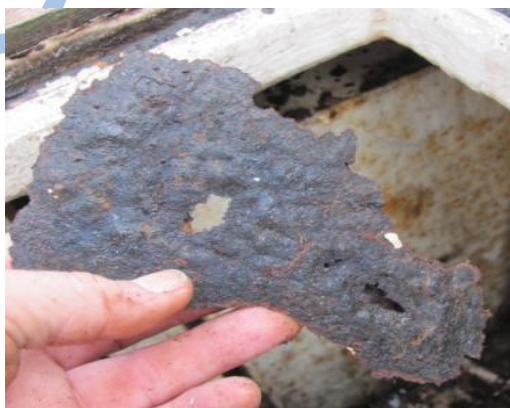
Corrosion peeled from top of port tank

- The corrosion on these tanks is severe where accessible and likely more severe on the inaccessible surfaces in contact with the wet plywood decks. Integrity of these tanks is suspect.

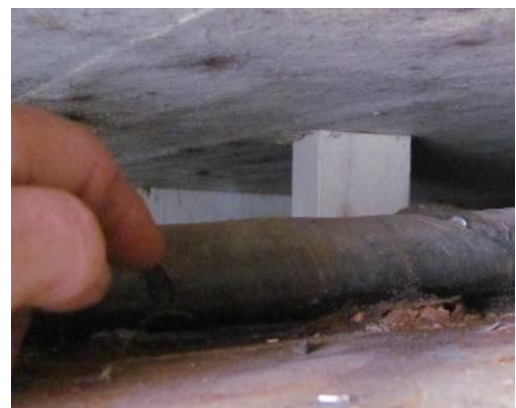
Deck support on fuel tank

6. TP1332E and ABYC "Diesel Fuel Systems" Standard H-33 require a minimum $\frac{1}{4}$ " air space be provided (when tank is full) between the tank and mounting surface and that the mounting surface be self draining in order to inhibit corrosion.

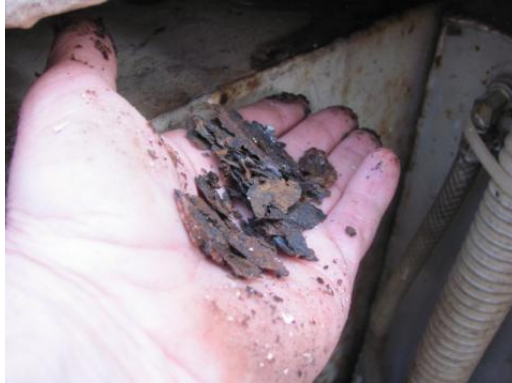
Corrosion from top of starboard tank

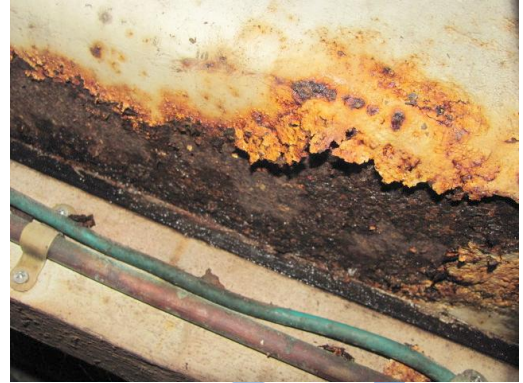
Accessible 4" of underside of port tank

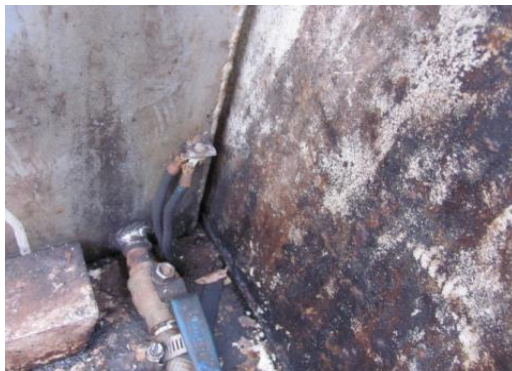
Steel and aluminum tanks likely in contact with each other

- These tanks may be in contact with the aluminum water tank and if not in direct contact their corrosion by products most certainly are, making both metals susceptible to galvanic corrosion.

23. This aluminum water tank sitting on a wet plywood deck is prone to pitting corrosion and likely galvanic corrosion due to its contact with oxides from the fuel tanks. Integrity of the tank is suspect.

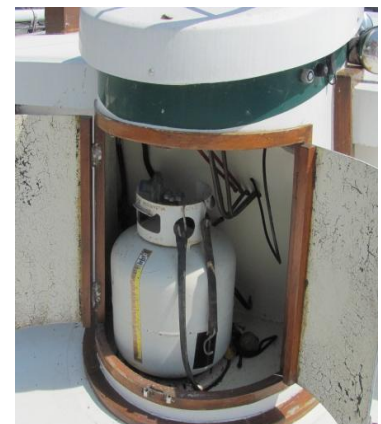
A galley stove is propane fueled and supplied from an expired propane bottle stored in a side loading, dedicated locker without direct overboard drainage or pressure gauge as required. The locker also contains a non-ignition protected engine ignition relay. The propane stove is not fitted with flame failure devices (thermocouples) and the fuel supply line is not accessible for inspection. **See comment (10).**

Side loading propane locker

10. NFPA-302 and ABYC "Marine Liquefied Petroleum Gas (LPG) Systems" Standard A-1 require that propane fuel bottles be stored securely in a dedicated, top loading locker with gasketed lid and direct overboard drainage with a minimum $\frac{1}{2}$ " inside diameter from the bottom of that locker and that the system be fitted with a pressure gauge. These same standards also require all appliances be fitted with flame failure devices (thermocouples). The propane tank certification has expired and the tank should be replaced.

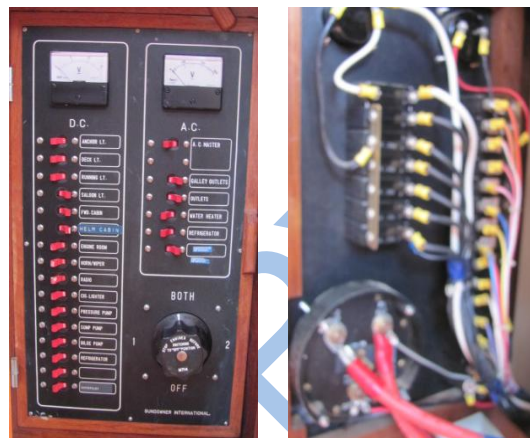
AC panel : Original equipment type panel with single pole main breaker, volt meter and accessory breakers in good visual order but sharing a panel with the DC system without AC/DC separation and without a polarity indicator. **See comment (16a & b).**

Shared DC & AC panel

14. Repair or replace depth sounder as required.
15. Replace wiper blades.
- 16b. Transport Canada "Constructions Standards For Small Vessels", TP1332E requires AC and DC distribution systems not share the same panel board and if both systems share a common enclosure must have a means of clearly separating the two systems with a dielectric barrier.

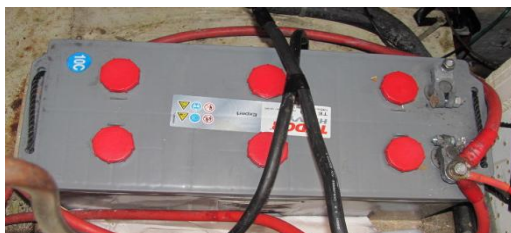
Batteries : Two sealed 12VDC, 140amp/hr, one is in an FRP box with lid and one is not in a box, has no means of securement, no positive terminal protection and the house battery has no fuse protection. **See comment (20).**

No box, no fuse, no terminal protection

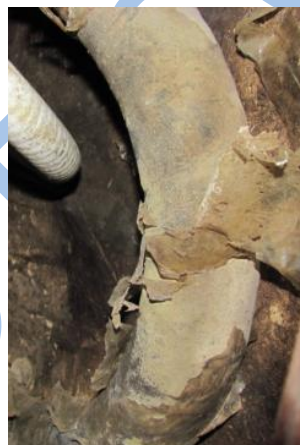
There is a strong odor of waste from under the vanity and the waste hose is degraded and not of a sanitary grade type. **See comment (25).**

Degraded waste hose

25. Replace waste hose with sanitary grade material.
