Service Sheet No.: 001/69

GR32

Adjustment of Interstation Stainless Steel Cable.

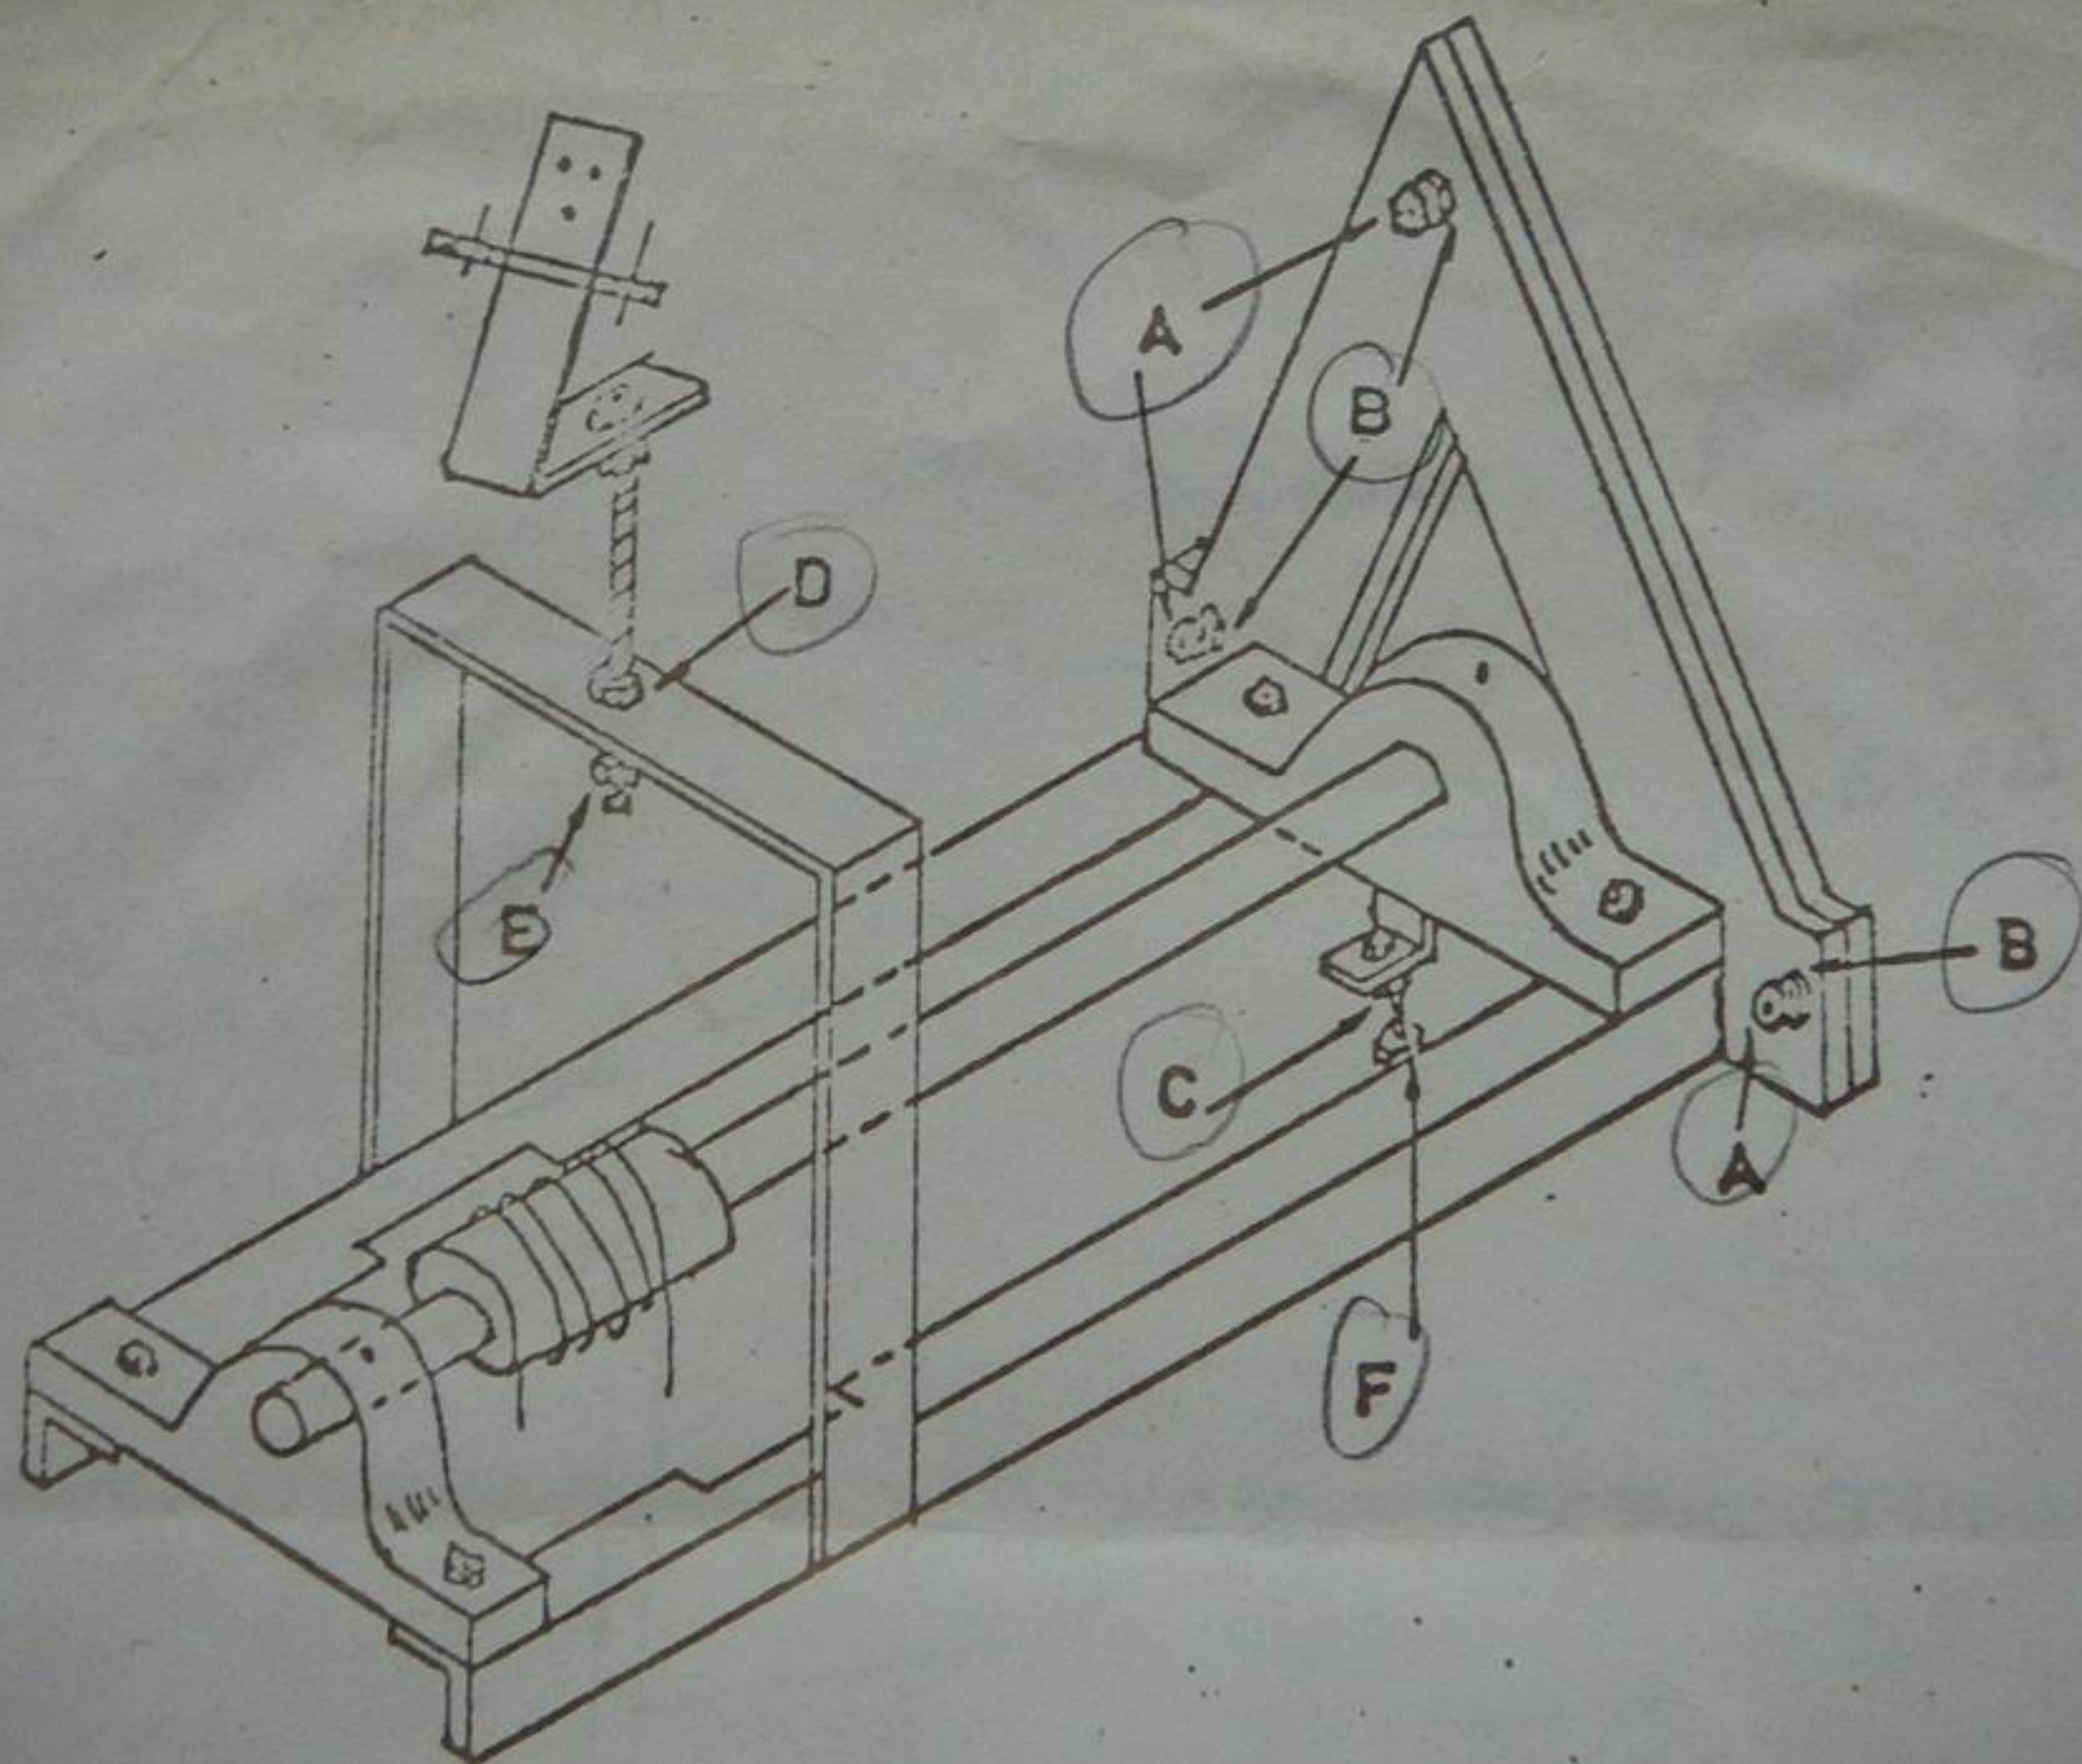
WIRE ROUTING.

The 3/16" wire is fed through the upper drum and locked at its centre with the two Allen screws. The two ends are each wound three times around the drum, (as shown in the sketch) before passing through the stainless steel guides and black plastic tube to the lower station.

At the lower station each wire is wrapped three times around the drum as shown in the sketch. The ends of the wire are then passed through the drum and locked with Allen screws.

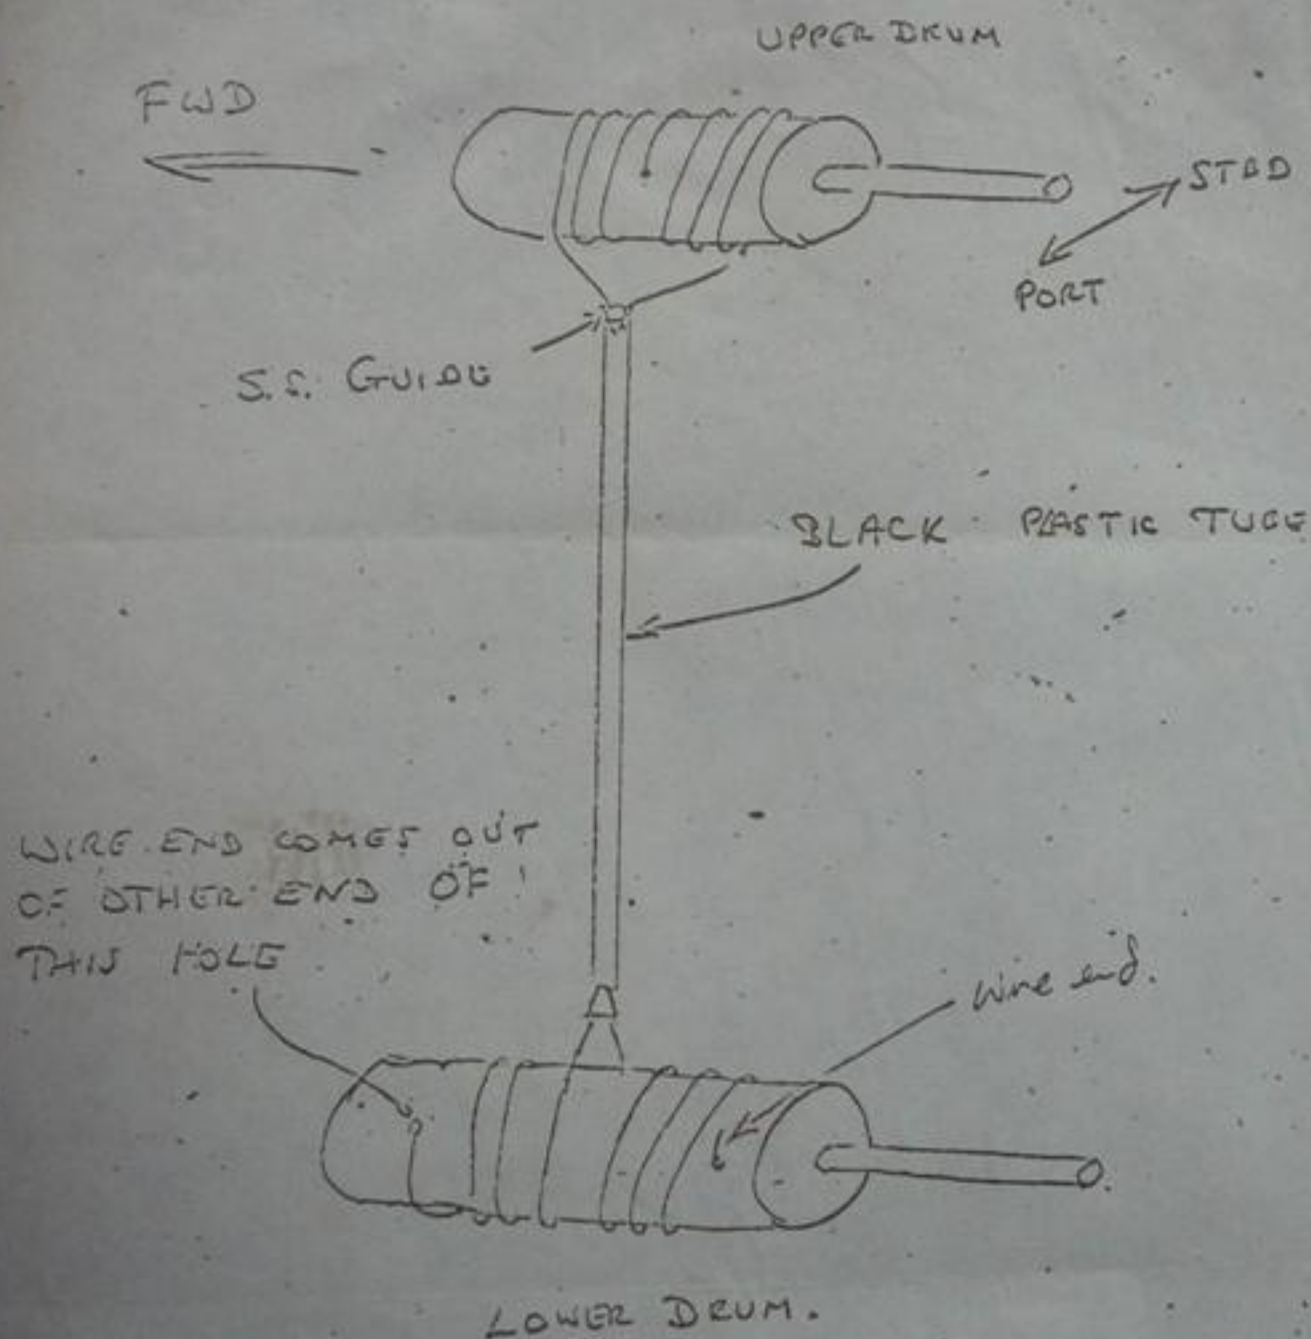
The upper and lower steering units are connected by a stainless steel cable which passes around 3" diameter brass drums. The centre of the cable is fixed to the upper drum and the two ends are fixed to the lower drum. At these fixing points, the cable passes through holes drilled in the drum and is held, at each point, by two set screws, one on top of the other.

The tension of the cable is adjusted by raising the complete upper station steering unit.

- (1) At upper station loosen locknuts A and also mounting nuts 'B'.
- (2) Loosen locknuts C and D used for securing adjusting screws.
- (3) Tighten adjusting screws E and F until cables are taught.
- (4) Tighten all locking screws.

- (1) Remove lower station instrument panel by lifting out.
- (2) From the drum remove the outer Allen screws used to lock the screws clamping the wire.
- (3) Loosen inner clamping screws.
- (4) Pull on the loose ends of the stainless steel cable to tighten the steering cables as much as possible.
- (5) Tighten clamping screws and replace lock screws.
- (6) Replace instrument panel.
- (7) Carry out final tightening of the cables by following the Fine Adjustment Procedure.
