Grand Banks Holding Tank Discharge Tube Replacement.

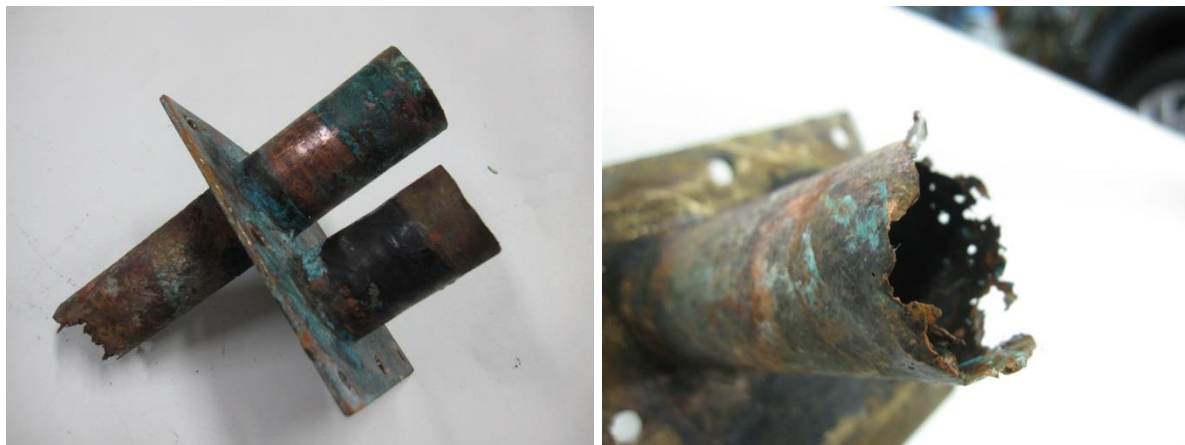
In trying to figure out what was wrong, I had the “joy” of discovering that the discharge tube for the holding tank on my 1994 GB 42 Classic had corroded off, making it impossible to pump out more than the top few inches of the tank. Thanks to the input of several other GB owners who have had to deal with the same problem, I was able to fabricate a replacement from non-corrosive (and relatively inexpensive) components.

Since the corrosion of the discharge tube appears to be the result of an inappropriate choice of materials by Grand Banks when the boat was constructed and since other owners of older boats may face this problem in the future, I thought I should share how I made the repairs.

I located the metal plate where the inlet and outlet hoses attach on the top of the holding tank behind the generator (and not much fun to get to). The plate is 5 inches square and appears to be made of bronze. It is attached to the tank with 8 stainless steel bolts. There is a metal rim molded into the inside of the tank that has threaded holes for the bolts. The inlet and discharge tubes for the tank are made of copper and are brazed on to the plate; the inlet tube extending above the tank for attachment of the hose leading to the head and the discharge tube extending both into the tank and above the tank for connection of the discharge hose. Here are photos of the removed plate and tubes. Note how the discharge tube has simply dissolved inside the tank.

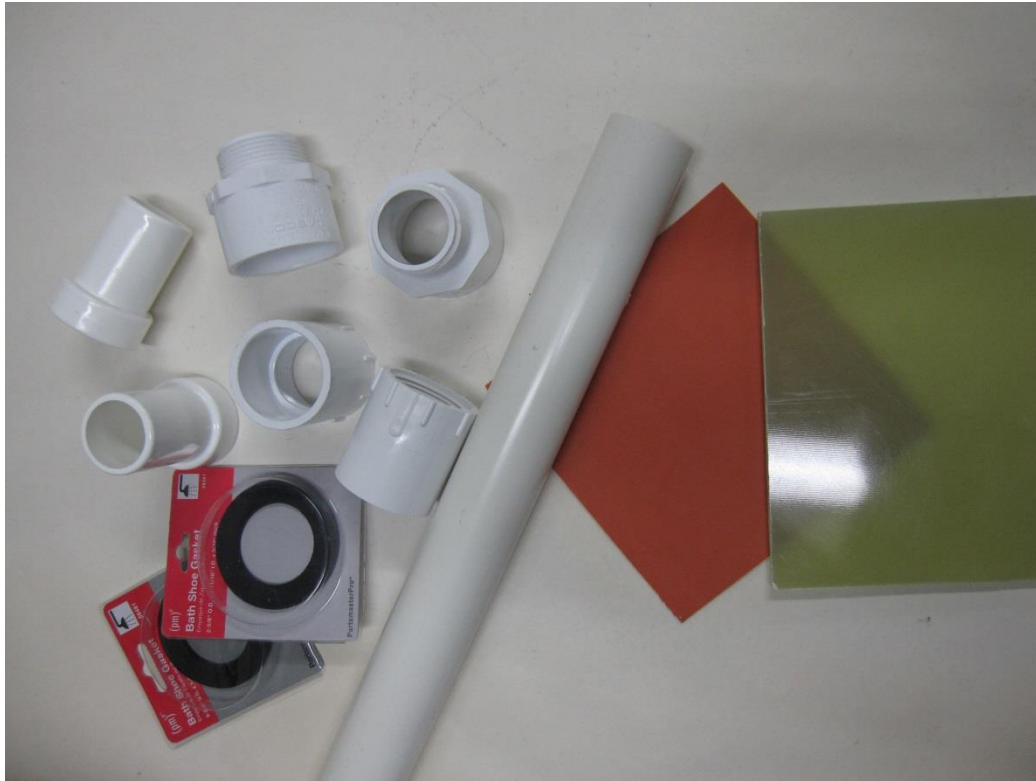
I fabricated a new plate and tubes using PVC for the plumbing and a piece of fiberglass board for the plate. The PVC pipe fittings are available from Lowes or Home Depot (with the exception of the hose adaptors). I got the fiberglass board from Jamestown Distributors (www.jamestowndistributors.com) and I obtained two PVC custom hose adaptors from Marine Sanitation & Supply (www.marinesan.com) in Seattle. I sourced a piece of rubber gasket material from

Home Depot from which I cut a sealing gasket for the plate. I also found tub drain gaskets which sealed the pipe/plate connections at Home Depot. Here are the raw materials.

- 2 - 1 1/2" to 1 1/4" male threaded adapters
- 2 - 1 1/4" female male threaded adapters
- 2 - custom hose adapters *
- 1 - length of 1 1/4" Schedule 40 PVC pipe
- 1 - fiberglass board backing plate **
- 1 - 6" x 6" rubber gasket blank (comes in pack of 2, black and red)
- 2 - rubber tub drain gaskets

* Marine Sanitation & Supply, product code 307341513

** Jamestown Distributors, item number COM-G10 Backing Plate Fiberglass 1/4" x 12" x 12"

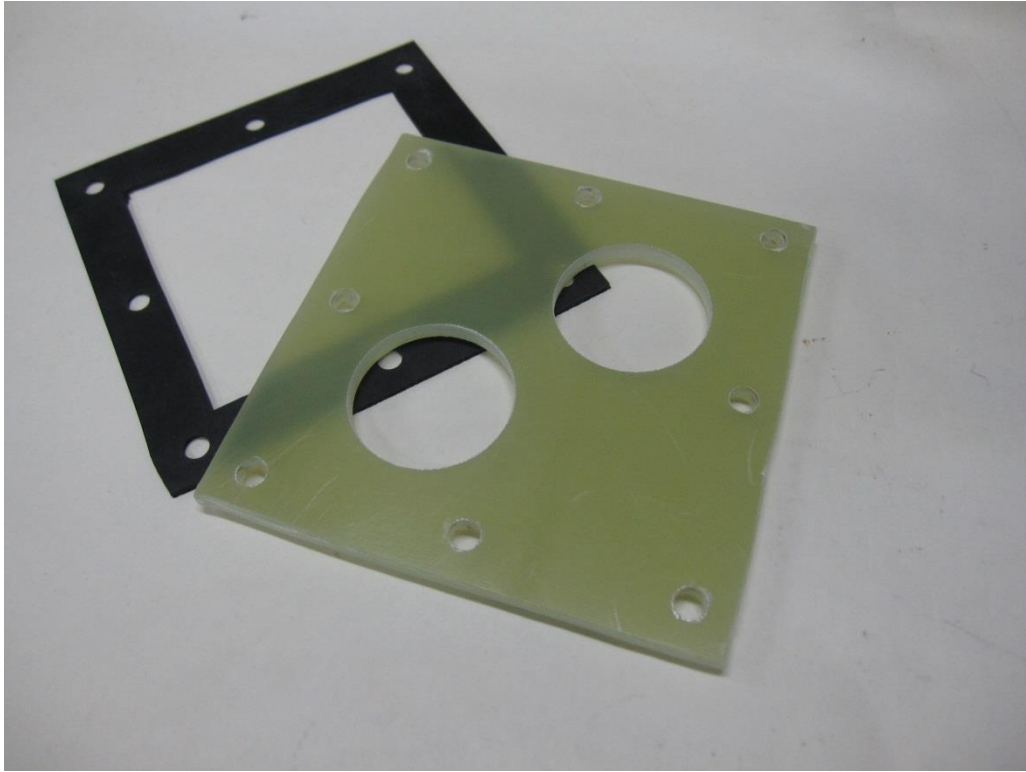
After cleaning up the original plate and tubes (and cutting off the stub of the discharge tube), I used it as a template for cutting out the replacement plate and locating the bolt holes. The fiberglass board was easily cut to size with a fine-toothed sabre saw (if you have it, a band saw would work great too). After covering the entire surface of the new plate with blue masking tape, I marked out the holes for the tubes and the bolts. I first used a small diameter drill bit to make pilot holes and then drilled the bolt holes with a 9/32" high speed bit and the tube holes with a 1 5/8" hole saw. I

then cut out the rubber plate gasket with a razor knife and drilled the holes for the bolts with the 9/32" bit. Here are the finished pieces.

IMPORTANT NOTE: The actual opening in the tank that the plate covers is only 3 1/2" square. Thus, the pipe fittings must be located very carefully to fit. One of the most difficult parts of the project was carefully measuring where to drill the holes for the pipes so that the pipe fittings could be as close together as possible in order to fit through the square opening in the tank top. This is also why I used 1 1/4" PVC pipe instead of 1 1/2", as I would have preferred. Even using the smaller pipe, I still had to grind a bit at the corners of the tank opening (and the metal inside rim) to make sure the pipe fittings would fit through).

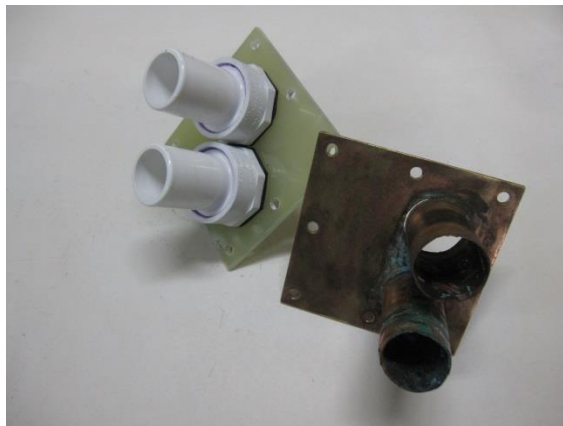
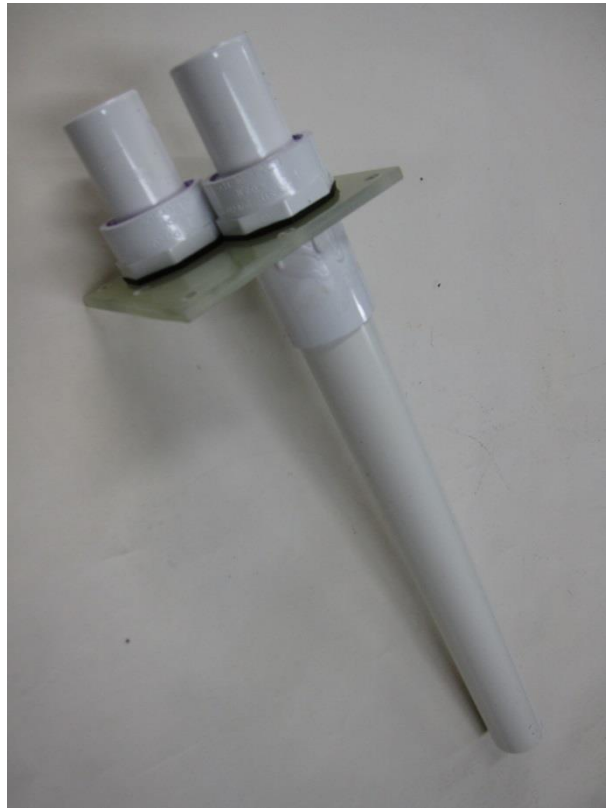
Before assembling the parts, I cut down the male PVC pipe fittings so they would match the custom hose adapters. I also cut off most of one of the female PVC fittings since it would only be used as a nut to secure the inlet pipe fitting.

I cemented the custom hose adapters into the male PVC fittings and then assembled them to the plate using trimmed down tub gaskets to make sure there is a good seal. I then screwed on (and cemented) the female PVC fittings to the male fittings. I postponed cementing the PVC pipe to the discharge fitting until making a careful measurement of the depth of the tank. I then cut off the PVC pipe at about a 45° angle at a length that would put it approximately 1/4" from the bottom of the tank when everything was assembled. I then cemented the cut pipe to the full length female fitting.

Here is the assembled plate and fittings shown with the original it replaces. The last picture shows the attachment of the discharge tube.

All that remained to return the holding tank to functionality was to bolt the plate assembly to the top of the tank (using the new rubber gasket I made) and re-attach to inlet and discharge hoses. A little trimming of the hoses was required since the hose adapters are slightly longer than the original copper pipes.
