Five Ways To Reduce The Risk Of Shaft Failure

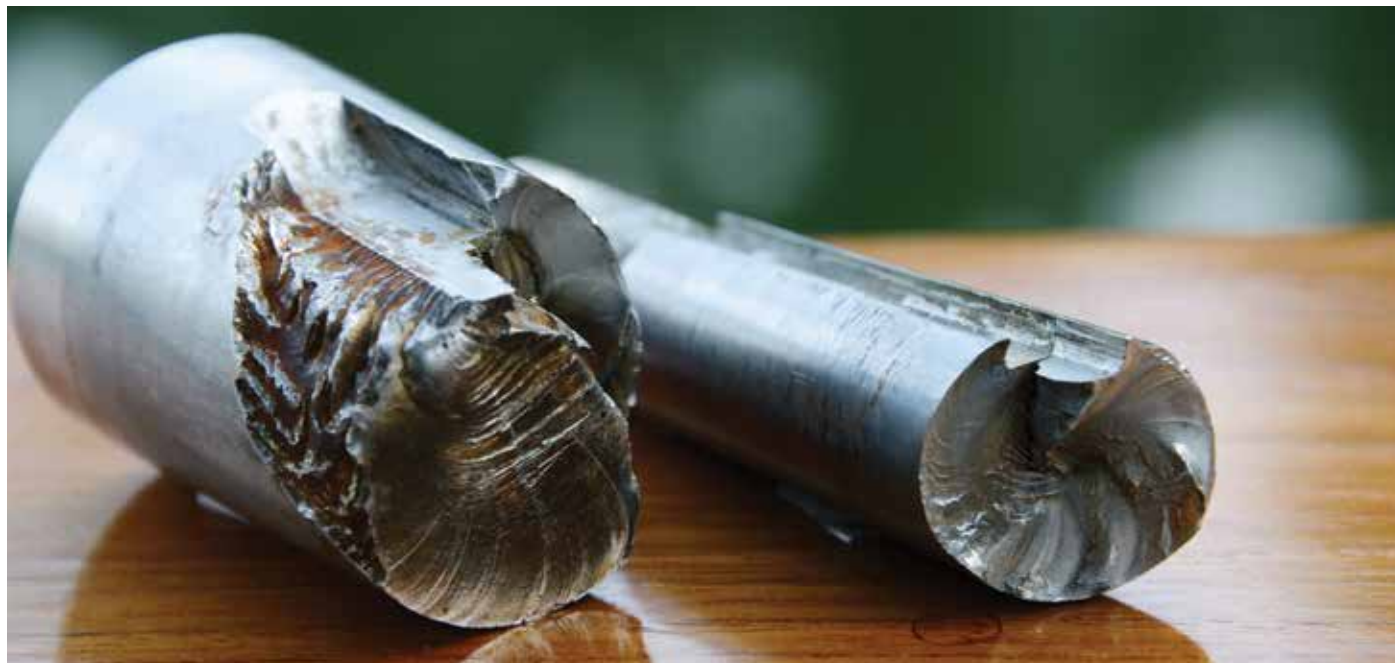
These shafts failed like most—at the propeller hub. Liquid penetrant testing should be done in this critical area.

Whenever you have your prop pulled, your shaft removed, or prior to any extended offshore voyaging, request a liquid penetrant test in the highest stress areas, around the keyway and just forward of the propeller hub. When cracks appear, the shaft should be replaced.

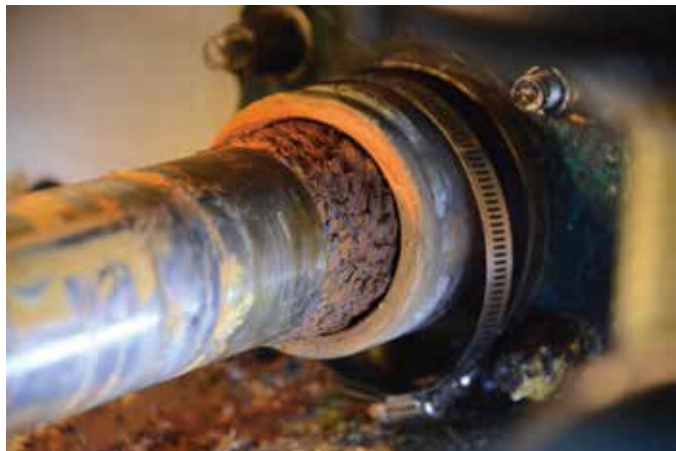
Low-grade alloy immersed in an oxygen-starved environment does not hold up well. Severe scaling and corrosion have destroyed this shaft in the seal area.

When the oxide surface film breaks down, the exposed metal loses its non-corrosive properties. The exposed metal will break down, forming a small hole or pit. This pitting tends to develop in areas where water flow is restricted, such as shaft seals and bearings. These happen to be areas hidden from view as well, keeping the pitting concealed until the shaft is pulled out.

At what point does pitting threaten the integrity of the shaft? That question poses a difficult judgment call. How deep are the pits and how many? Will the boat be inland or offshore? What is the budget? Generally, pitting less than 1/8-inch deep can be tolerated, but that might be trumped by an excessive area of pitting. A process known as “cladding” can restore a pitted shaft. Cladding involves machining, welding, more machining, and straightening, and must be done by a highly trained machinist. Due to the expense of cladding, it usually is not cost-effective for shafts under 3 inches in diameter. In addition to strength concerns, pitting in the bearing area or the shaft seal can damage the bearing or seal.

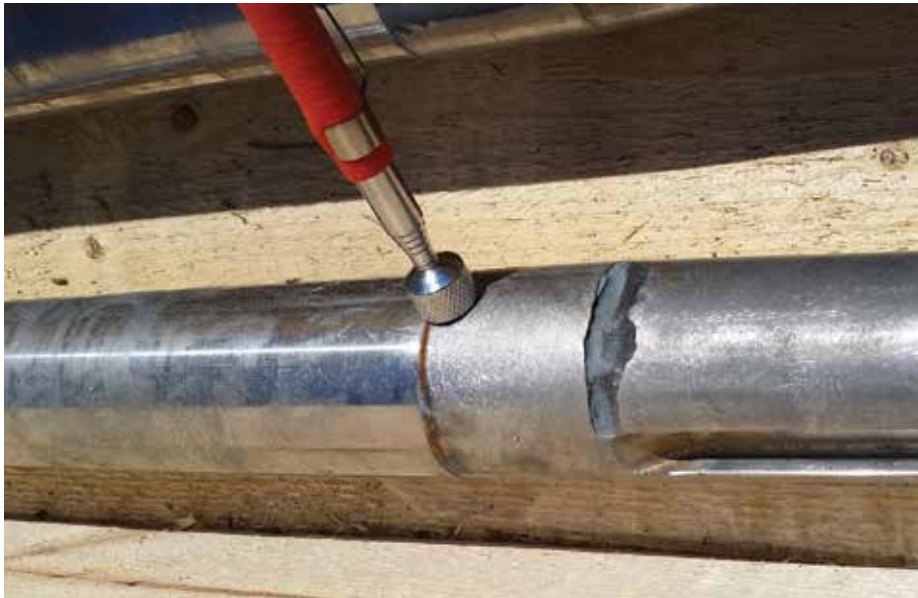
Only lower-grade alloys will attract a magnet. Severe crevice corrosion has developed at the forward end of the keyway area.

Ignoring the various trade names (Aquamet®, Aqualloy®, Nautalloy®), all use the same reference numbers, mostly 17, 19, and 22. The higher the number, the better the resistance to corrosion. For recreational cruisers, the choice comes down to 19 or 22. Grade 17 should not be used. If you are not sure what you have, use a magnet. Only 17 will attract the magnet (some Chinese alloys of 19 or 22 will attract a magnet, and that should also be a red flag). If your shaft attracts a magnet, it would be prudent to pull it before any trip and inspect it for pitting or crevice corrosion.

Although the chemical process for crevice corrosion does not differ from that of pitting corrosion, the causes vary. Crevice corrosion refers to a localized attack at the interface between two surfaces, or where a sharp edge occurs. This situation can occur, for example, where the forward end of the propeller hub meets the shaft. On lower-grade alloys this area will suffer from severe crevice corrosion (see below). On a microscopic scale, the same process takes place where small scars or nicks in the shaft surface develop. These small imperfections create flaws in that critical oxygen film, providing a foothold for crevice corrosion. One study published in the *Journal of Failure Analysis and Prevention*
