1 WATER TANK CASE STUDY-CANOE COVE 53

1.1 THE CANOE COVE 53

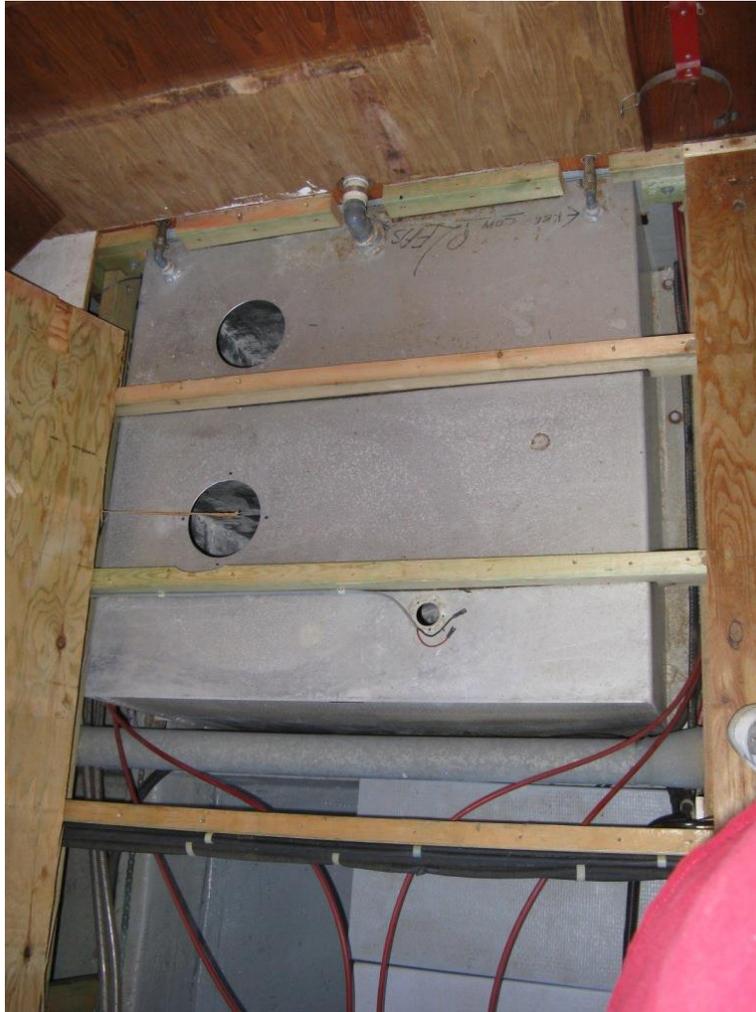
Figure 2. OEM Water Tank

The aluminum 200 gallon water tank (see Figure 2) is installed immediately under the deck beams, in between the two large fiberglass-encased fir longitudinal hull stringers that form the engine beds. The tank is a rectangular solid, and fabricated from ~1/8" welded aluminum alloy. It contains one transverse slosh baffle, midway between the front and back of the tank. The tank is held in place via two 2" x 2" aluminum angles welded to the sides of the tank, and lag bolted to the longitudinal stringers. Both the existing plumbing and lag bolts are easily accessed for removal from above. However, even though the tank is ready for removal from its resting place, it will be apparent that the tank is too large to be removed through the aft cabin door. So the 1st conundrum presents itself: to butcher the aft cabin door or cabin overhead to remove the tank intact, or to cut up the tank and remove it in pieces. My choice was to cut up the tank with a Sawzall (an easy task), and

remove it in pieces through the aft cabin door. While that choice was easy, it then presented an unintended consequence of this action: the new tank won't fit back into the boat! So, inevitably two new tanks small enough to fit through the cabin door must be designed to replace the single existing one.

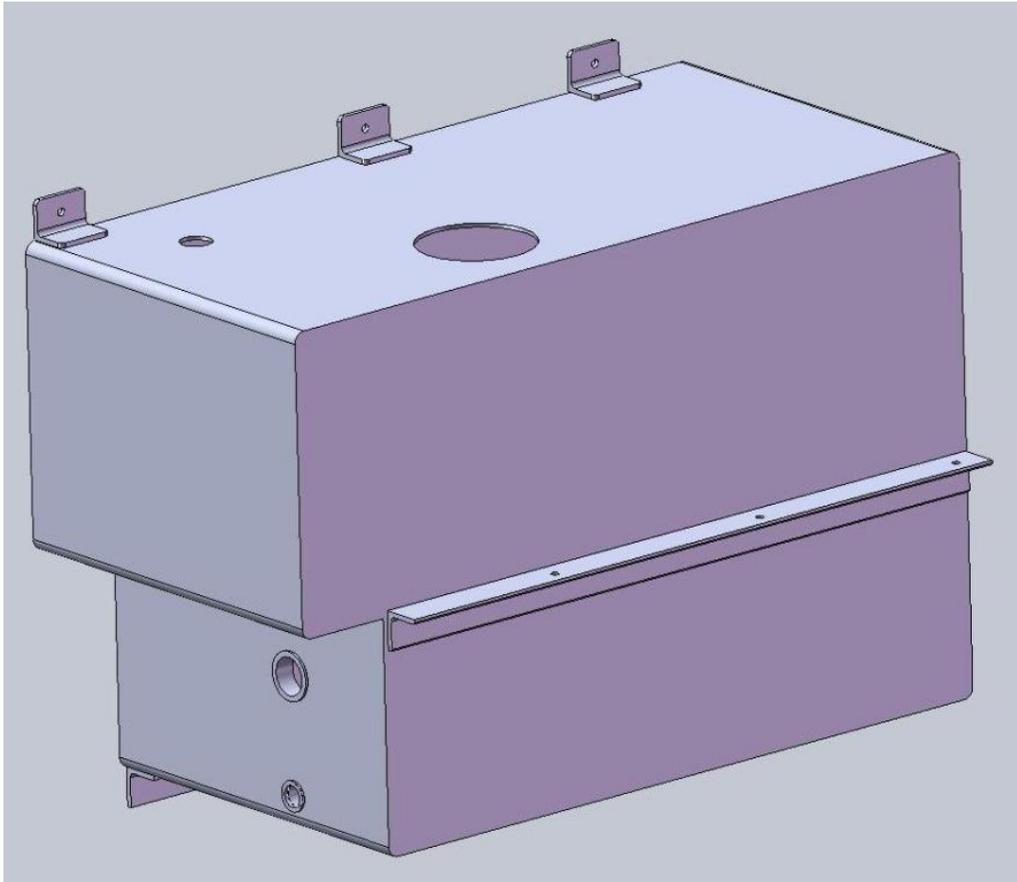
Figure 4. Starboard Tank (Port Side Mirror Image)

As I am a competent mechanical engineer with extensive machine design experience and access to various Computer Aided Design softwares, I decided to tackle the design and drafting tasks myself. The replacement tanks were designed to be inserted into the aft cabin singly, then bolted together, and installed into the existing void as a unit. Figure 4 is a solid model of the starboard tank. The port tank is a mirror image. Design of two tanks that function as a single unit was not entirely straight forward. Unless you are content to have two water fills, two vents, and two drain lines, some method of ganging the tanks together must be devised. In this installation, this was accomplished via a "spill pipe" that interconnects both tanks, and tee-ing the individual vent fittings into a common vent. The spill pipe was sized so as not to limit the transfer of water from one tank to the other during either filling or draining. The major difficulty with this concept was that the bulkhead that forms the aft limit to the tank cavity cannot be easily or prudently removed to provide space or access to the spill pipe. Hence, the tanks were designed with a step that accommodates the spill pipe. The tank dimensions were increased wherever possible to recover the lost volume from the step; the dual tanks have a 196 gallon capacity vice 200 gallons for the original. Note: reflection on the design some years later revealed the now-obvious point that the drain ports could have been enlarged and plumbed as the spill ports as well, saving one penetration per tank. Doh...

An inspection port was installed in the aft bulkhead to allow inspection and service of the spill pipe and drain ports without removal of the tanks, should leakage in this area ever occur. Every effort to prevent such leakage was accomplished by the use of 316L stainless steel pipe fittings, top-of-the-line Trident brand flexible water hose rated for food service, and double hose clamps on each connection.

In addition to the necessary spill pipe, vent, and fill fittings, a port was provided for a gauge fitting. A 6" access port was provided in the top of each tank, accessible through matching access plates in the deck under the

platform bed. Should it be necessary to inspect or clean the interior of the tanks, it is possible to remove the mattress, remove the lid over the storage area, remove the access plates, and reach the interior of the tanks. A feature this owner fervently wishes was provided in the initial installation! It might have prevented this entire evolution by allowing routine inspection and cleaning of the potable water system.
