DEGRADATION OF WOOD BY PRODUCTS OF METAL CORROSION

FOREST PRODUCTS LABORATORY

1974

By
A.J. BAKER, Chemical Engineer
Forest Products Laboratory,¹
Forest Service
U.S. Department of Agriculture

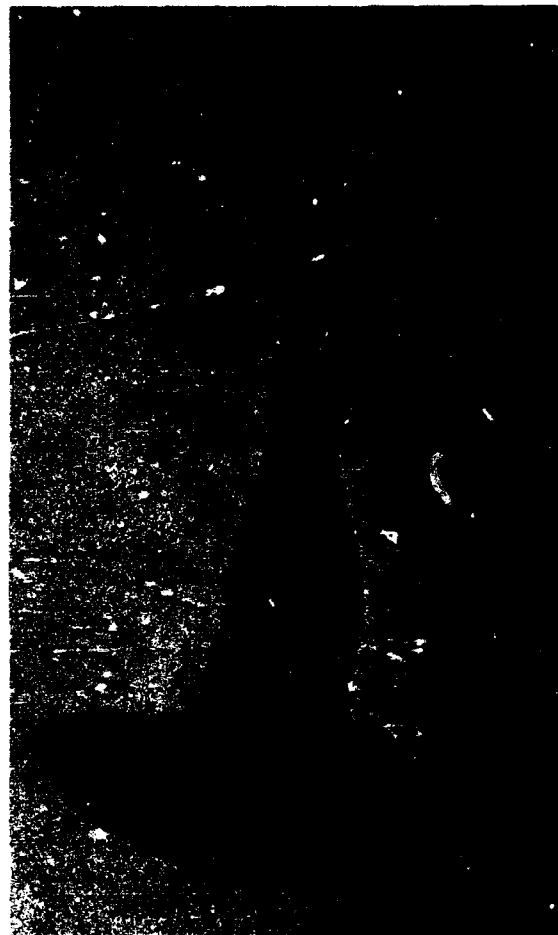
Figure 1.—Nail removed from barn siding shows crevice corrosion. (Note that shank has corroded away, whereas head and upper part of shank remain.) (M141 788-8)

Weakened wood is frequently noted around nails in old, weathered house and barn siding that is wetted by rain and snow. The wood that surrounds the nail is usually stained black. Nails pull from the siding with little resistance and frequently come out with some wood attached to the shank. After corrosion has progressed, the shank of the nail under the surface of the wood will corrode away and appear as shown in figure 1. Railroad spikes become loose because of weakened wood around the shank of the spikes. Rail tie plates also corrode and weaken the wood under the plate to the extent that the tie plate crushes the wood. Wooden vessels are said to have "nail sickness" because of weakened wood around metal fasteners and fittings.
