Marine Survey Report

Report Number : 2013P/2850

Date of Inspection : May 20 and 21, 2013. Title page photo May 17, 2013

Make of Vessel : The MIC is registered to Cherry Yachts, 454 S Queen St. HAMPTON, VA as the importer from Kha Shing Ent., Co., Ltd., 10 Kang Yang St., Hsial Kang, Taiwan R.O.C Marketed as a "Sundowner 30" and a "Regency 30".

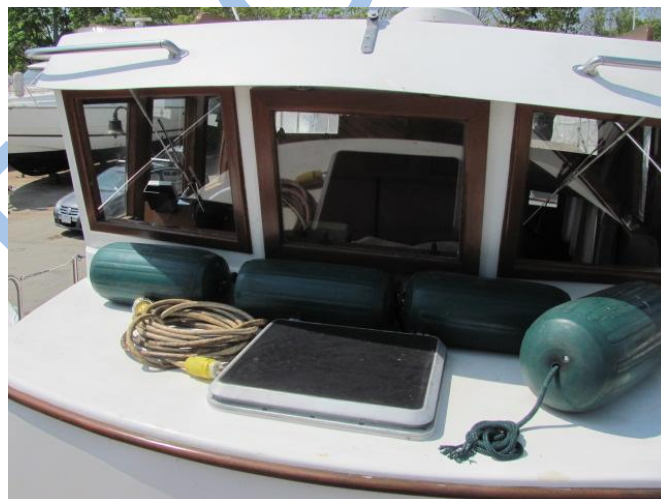
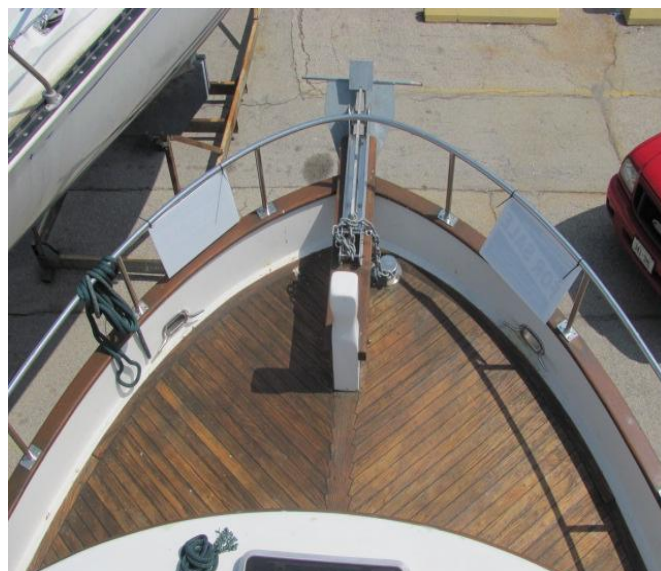
All pilot house and deck house windows are wood framed and all are leaking to some degree. Port and starboard pilot house sliding doors of wood are secure as are the aft deck house companionway hatch and door. Stainless steel grab rails are in good order as is the escape hatch on the trunk.

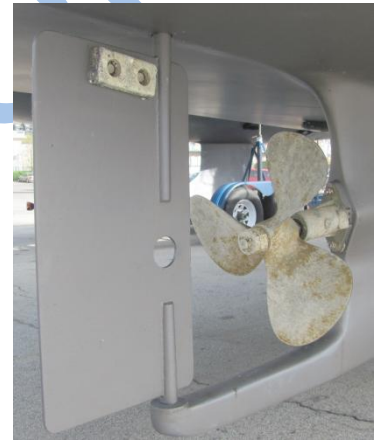
Hydraulic steering gear

Steering : Wagner single ran hydraulic steering is secure and responsive at both stations.

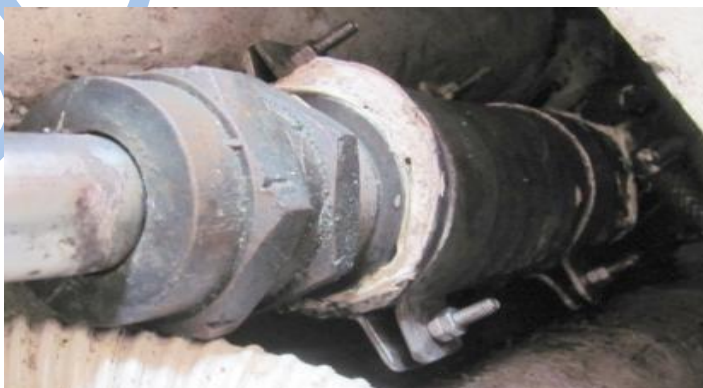
Stuffing box

Shafting : A stainless steel shaft is secured through bronze log with cutless bearing to bronze logs to compression type stuffing box and conventional flange and all are secure and in good order.

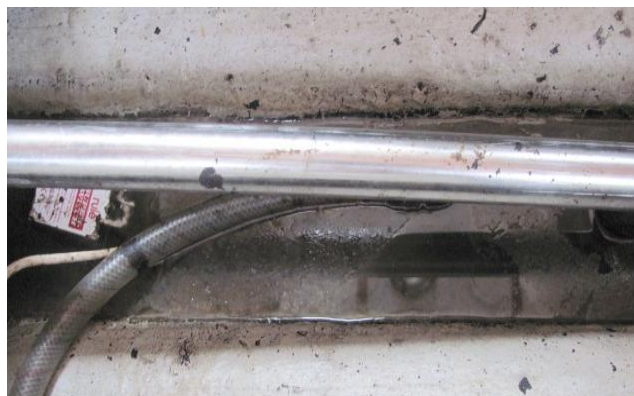
Bilge

The engine is quite clean but for oil on the port side of the gear reduction unit. Engine oil, coolant and gear reduction fluid are clean and at proper levels. The bilges all have a few inches of water with an oily film. **See comment (5a & b).**

- 5a. Oil on the gear reduction unit appears to be coming from the bottom of the oil filter or filter housing. Additional oil was visibly leaking during the sea trial. This may be simply a poor gasket seal or oil hose union. It should be repaired prior to any voyage.

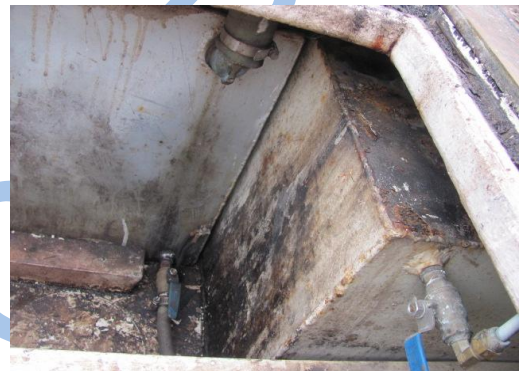
One steel tank is outboard on each side of the lazarette and both are mounted directly on wet plywood decks with an aluminum water tank in between. Wooden blocks directly on top of the tank are supporting the deck structure overhead. There is significant corrosion on the top of both tanks and severe corrosion on the bottom surface along the accessible aft 4". It is also likely that both tanks may be in direct contact with the aluminum water tank where galvanic corrosion should be expected. **See comment (6).**

Steel and aluminum tanks likely in contact with each other

6. TP1332E and ABYC "Diesel Fuel Systems" Standard H-33 require a minimum $\frac{1}{4}$ " air space be provided (when tank is full) between the tank and mounting surface and that the mounting surface be self draining in order to inhibit corrosion.

- H-33 also requires metallic fuel tanks be installed so that water will drain from the top surface of the tanks and that metallic tanks be insulated from any other metal to avoid galvanic corrosion.
